**Bridge Detailed Examination Report**

<b>ELR:</b> LJT2		<b>Contract Mileage:</b> 024 m 0528 yds 24.00 chs				<b>Struc. Ref</b> 112	
<b>Examination Type:</b>		Bridge Detailed		<b>NR ID:</b>	12015186	<b>Exam Date:</b>	11-Feb-2014
<b>Area:</b>	Central West			<b>BRS:</b>	0	<b>OS Ref:</b>	SH70404460
<b>Structure Name:</b>	BR112 TANYDDYNGWYN			<b>Type:</b>	BO	<b>Exam ID</b>	5026678
<b>Route:</b>	Blaneau Ffestiniog Branch			<b>Complete Examination:</b>		No

This structure carries an occupation road leading to open fields on the upside, over a disused branch line. It is constructed of four steel main girders with three brick jack arches in between on stone abutments and wing walls the parapets on the span are of mild steel panels.  
The examination was tactile and carried out utilising ladders, prodders and hammers.

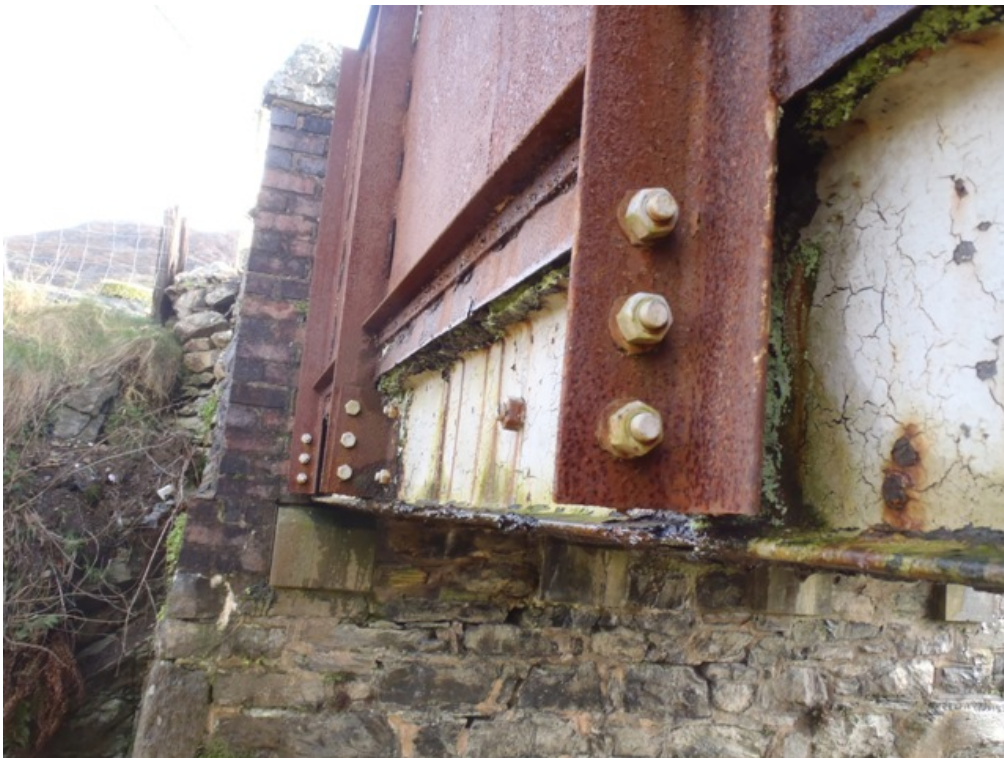
Both outer main girders – severe corrosion with knife edging throughout outer edge of top flange Photo 6,  
Both outer and both inner main girders – extensive moderate/severe corrosion sores throughout bottom face of bottom flange. Photos 7,8

Photo 6 typical corrosion to outer main girder 11/02/2014

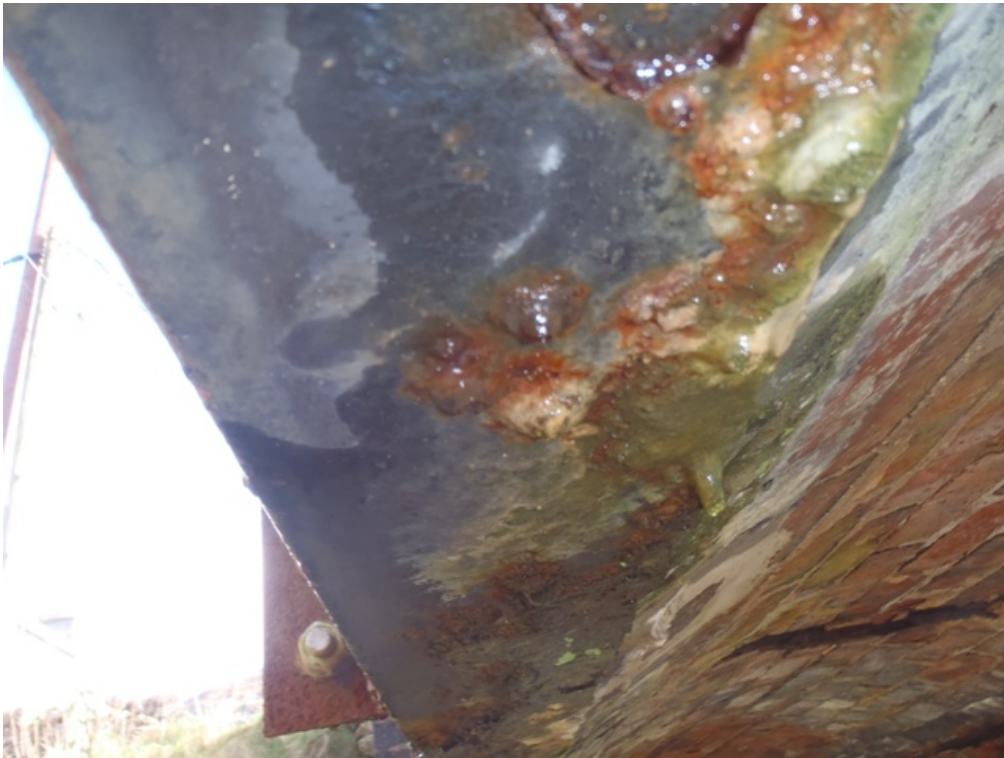
Photo 7 typical corrosion to underside of main girders 11/02/2014

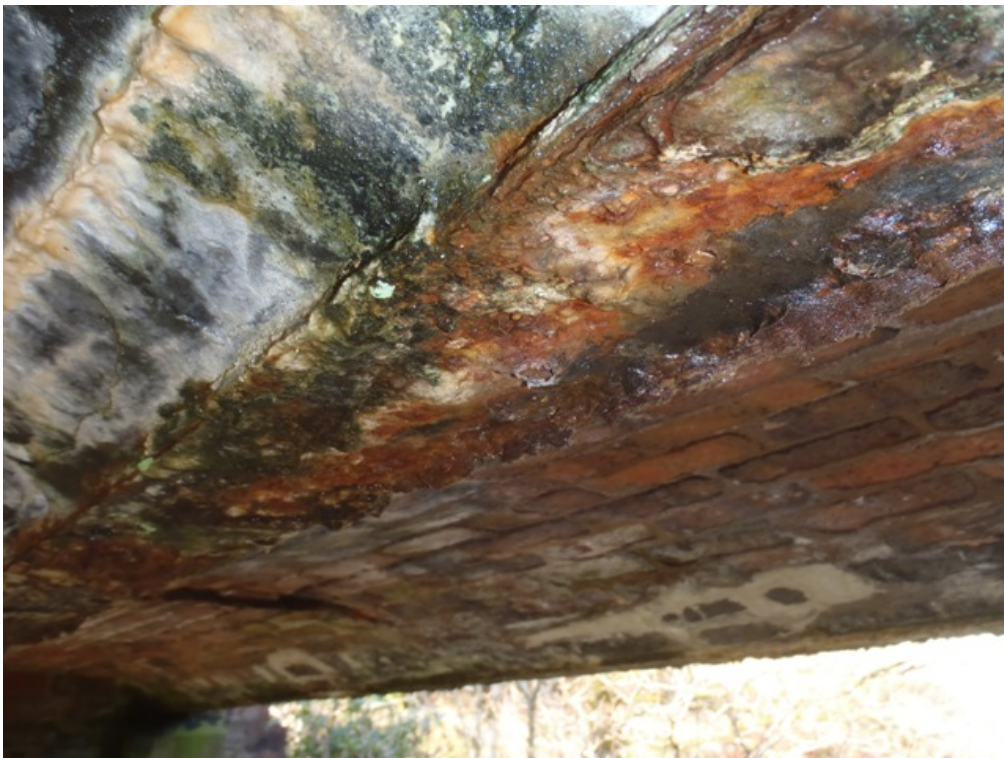
Photo 8 typical corrosion to underside of main girders 11/02/2014

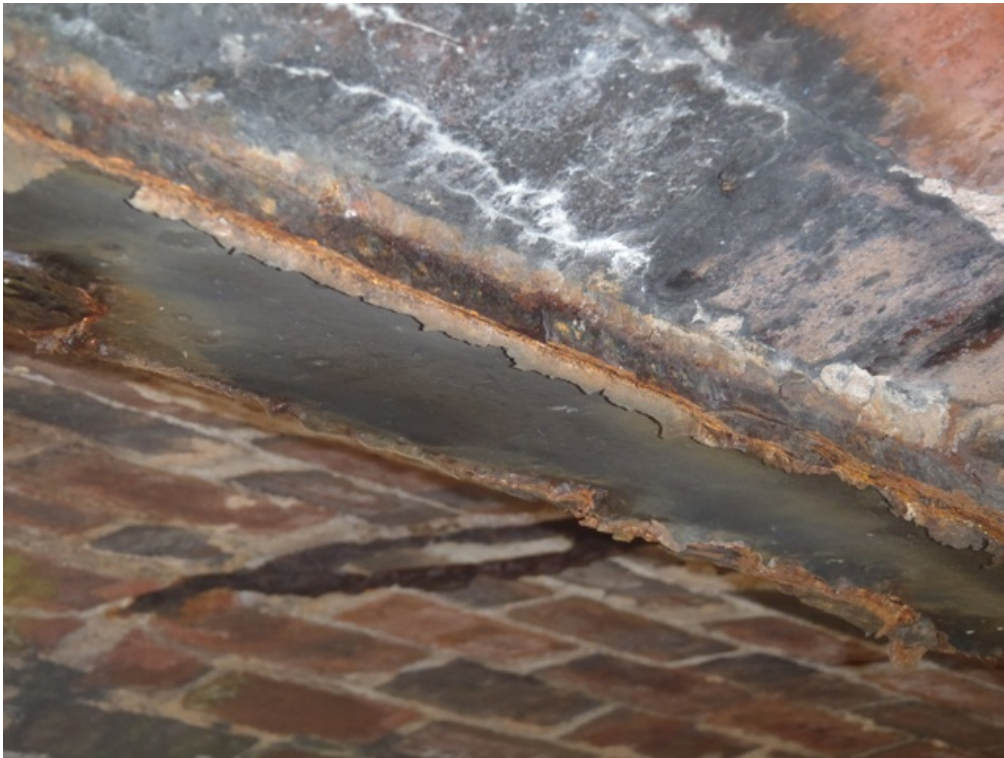
Paint cover generally broken down, and now largely non-existent - allowing extensive corrosion throughout superstructure. Photo 9.10

Photo 9 typical paint failure at main girders 11/02/2014

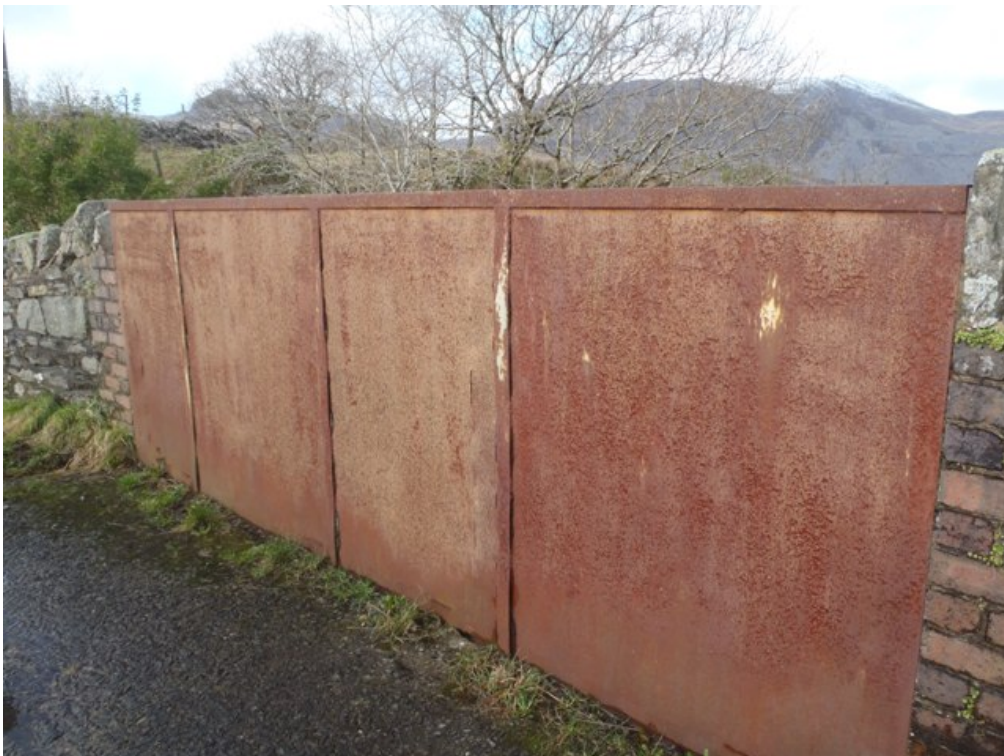
Photo 10 typical paint failure at parapets 11/02/2014

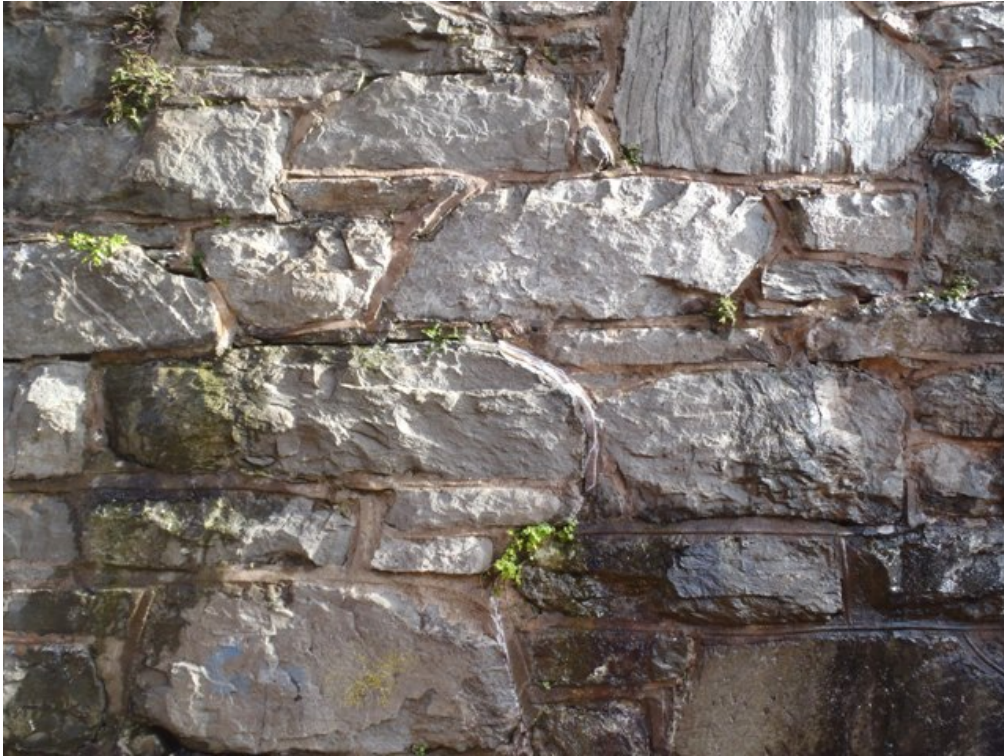
Both abutments – similar, 1mm wide vertical, stepped bed joint fractures, from ground level to cill, at centre of abutments – as last detailed examination. Photos 11,12  
Occasional, isolated open joints, to 150mm deep, generally throughout both abutments – 4m.sq total. Photo 13

Photo 11 fracture at downside abutment 11/02/2014

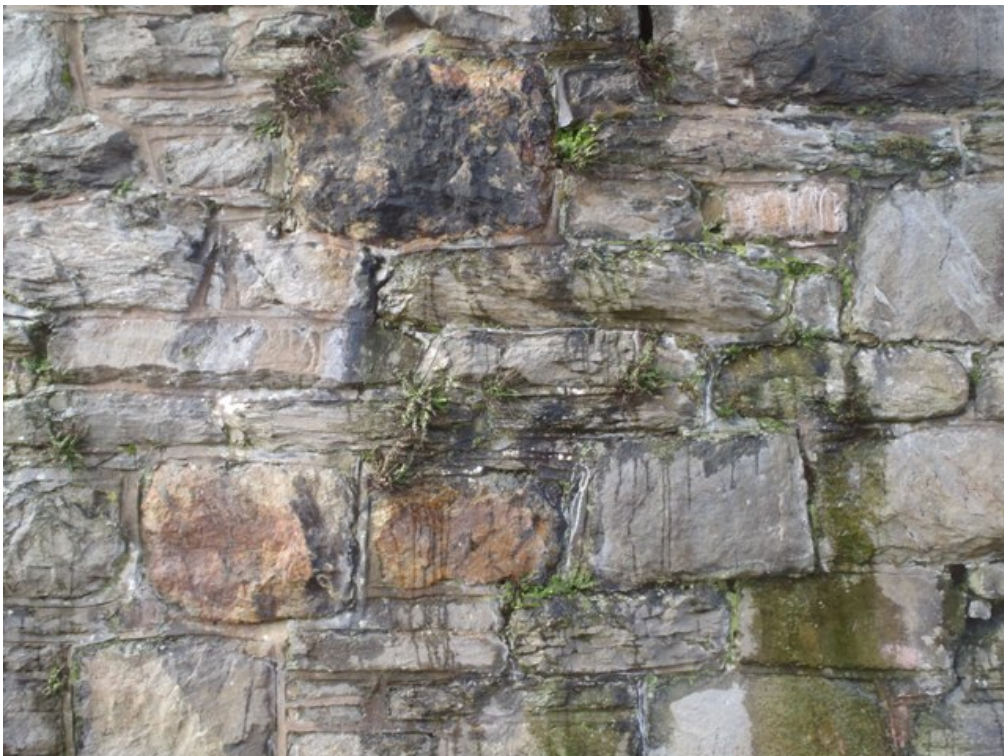
Photo 12 fracture at upside abutment 11/02/2014

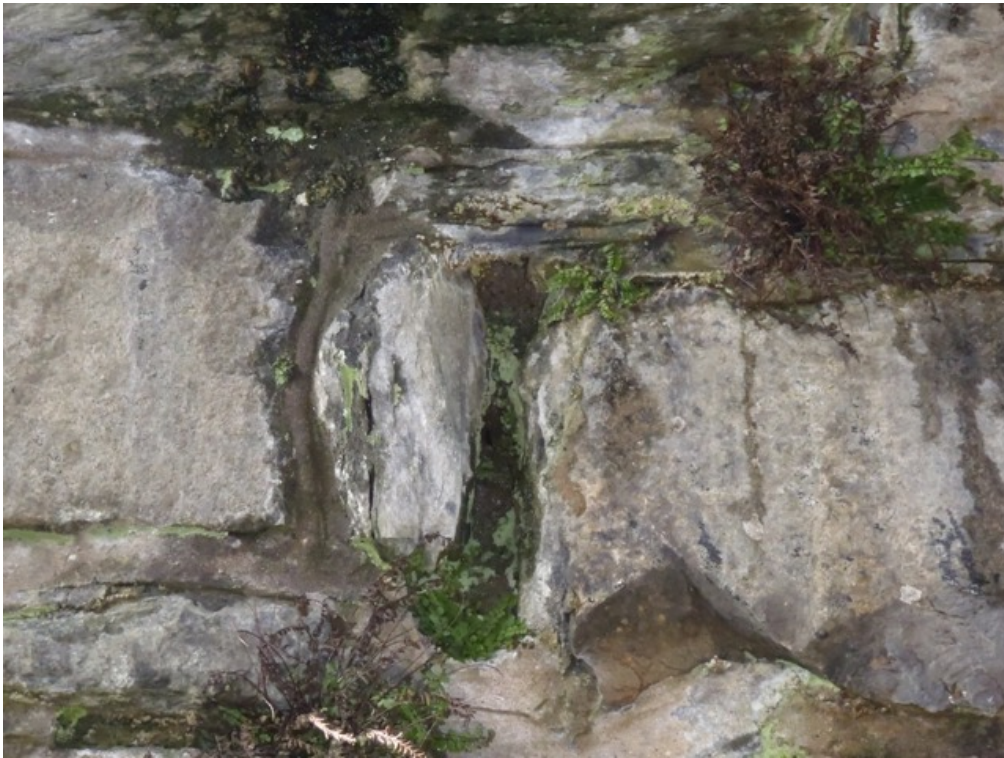
Photo 13 typical open joints at abutments 11/02/2014

5	Rake out to sound material and re-paint isolated areas of deep open joints.	Abutments, wingwalls and parapets	4000.00	4yrs	20 m2	2	3	M6	Hand Pointing

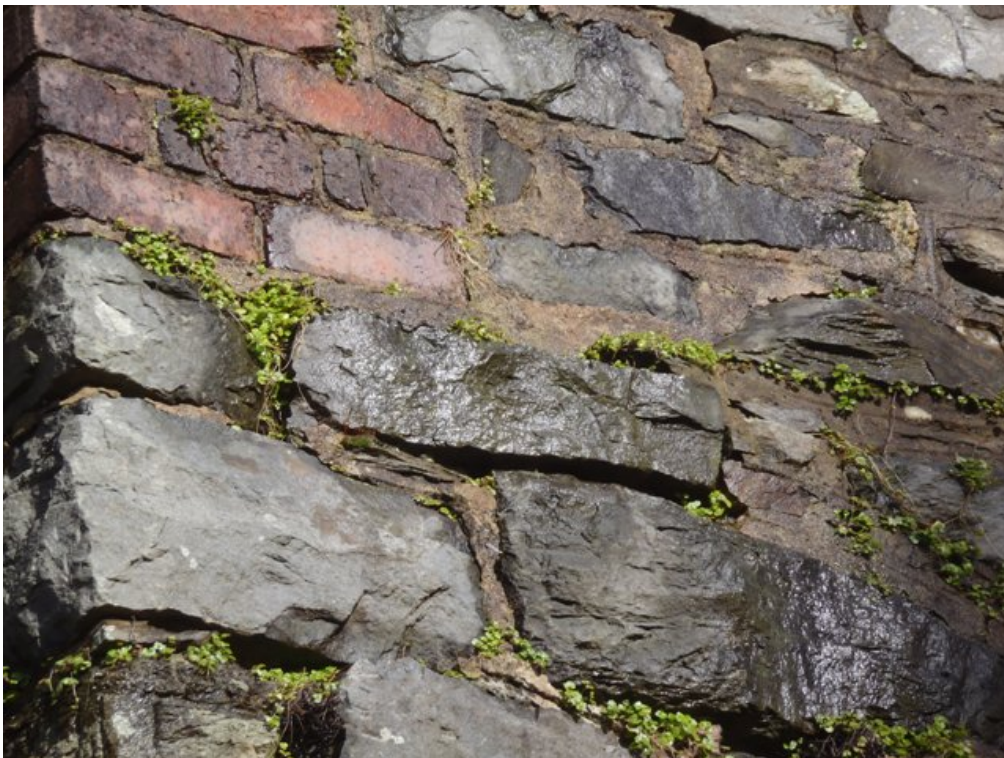
Occasional, isolated open joints, to 100mm deep, generally throughout all 4no wing walls – 8m.sq total. Photo 14

Photo 14 typical open joints at wingwalls 11/02/2014

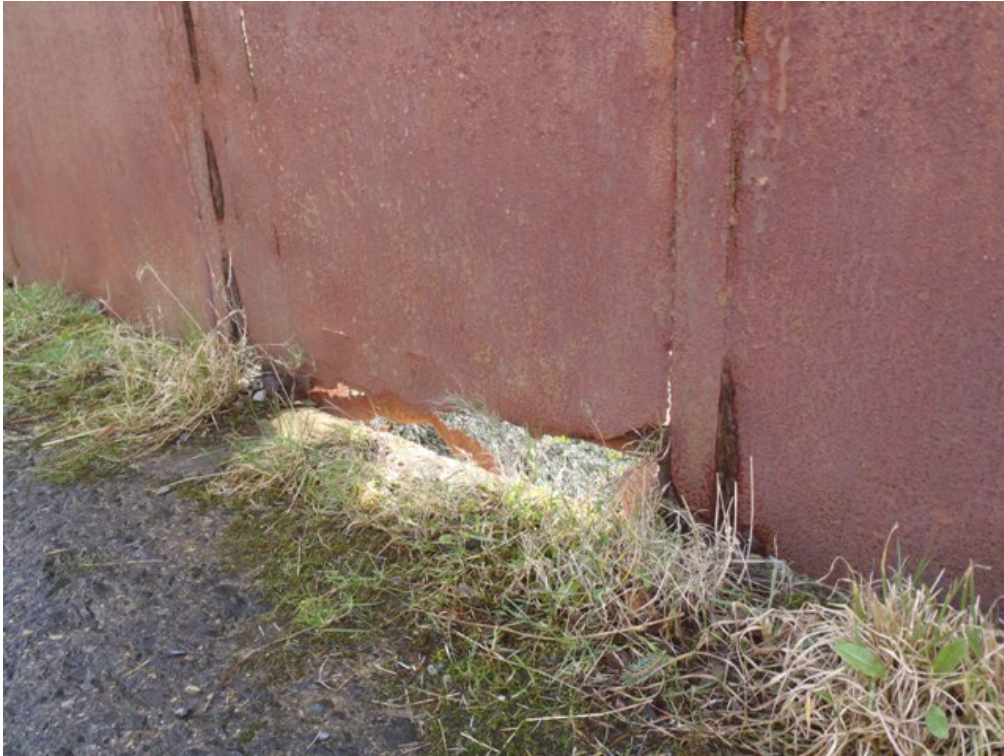
All 3no plate panels on each parapet show extensive moderate/severe surface corrosion throughout, Photos 15,16

Photo 15 typical corrosion at Trawsfynydd end parapet 11/02/2014

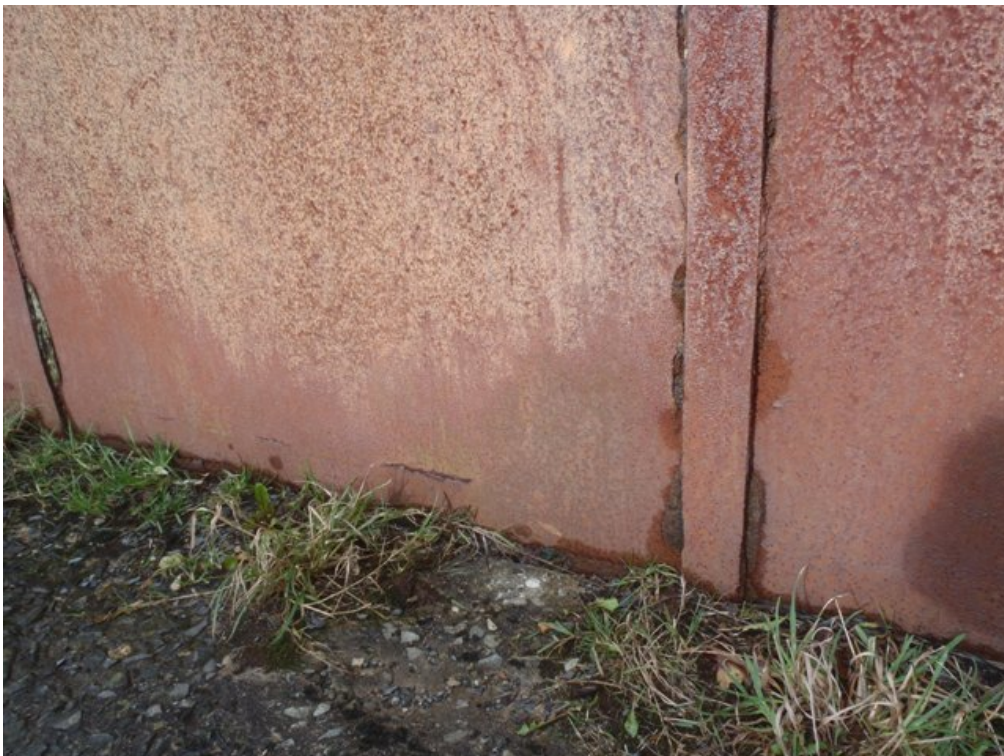
Photo 16 typical corrosion at Blaenau end parapet 11/02/2014

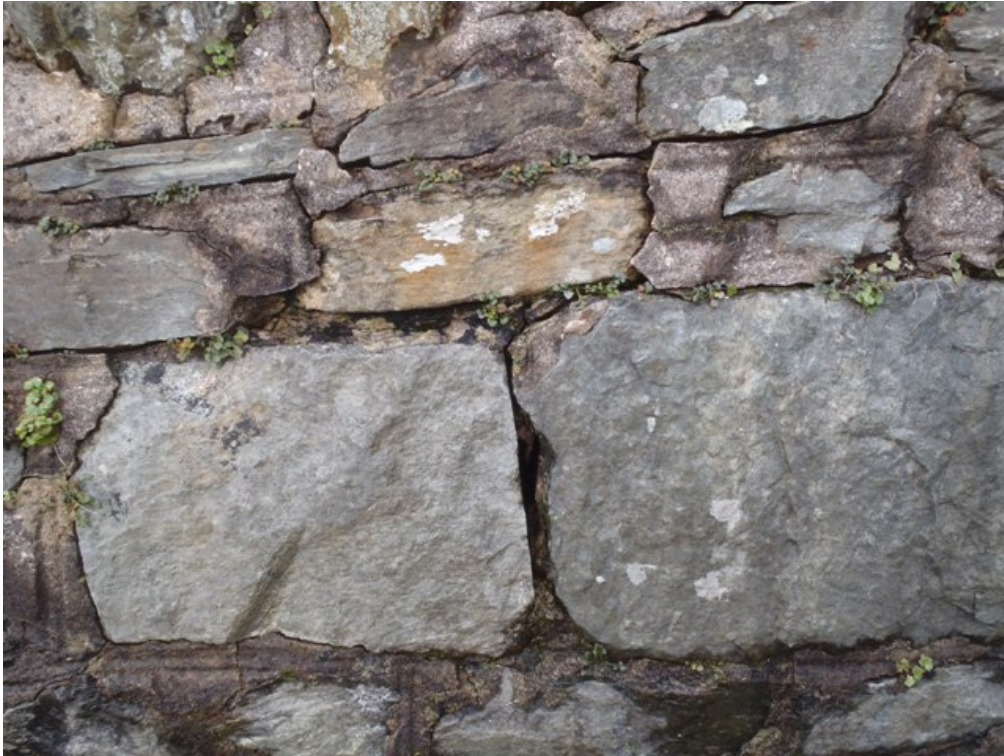
Occasional, isolated open joints, to 100mm deep, generally throughout all 4no parapet approach walls – 8m.sq total. Photo 17

Photo 17 typical open joints at parapet walls 11/02/2014

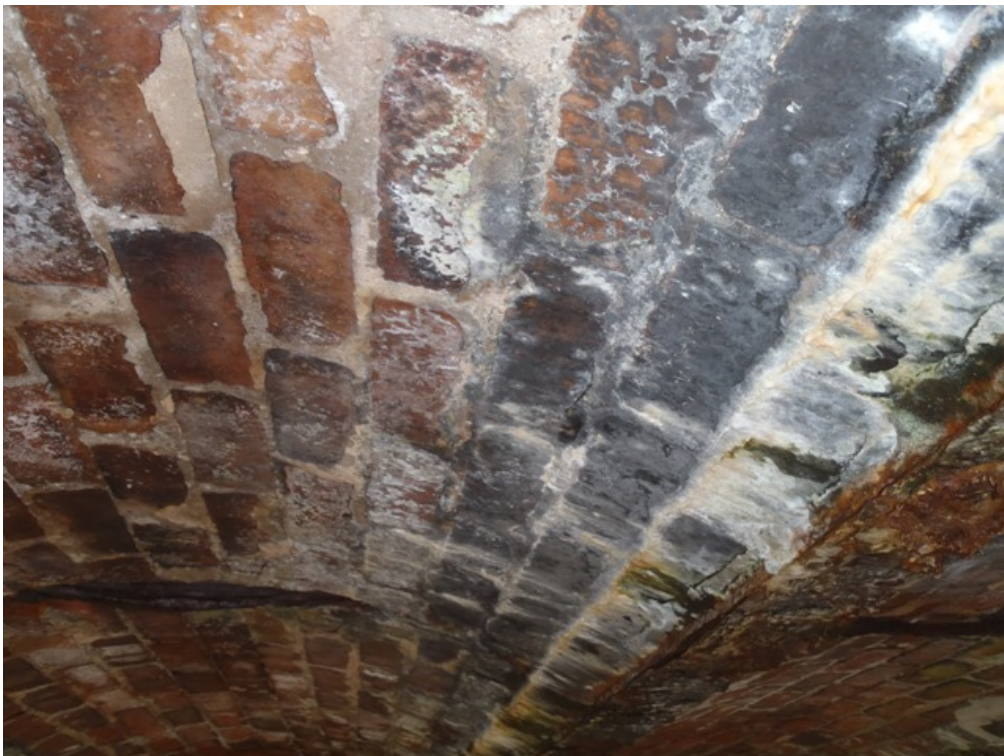
Areas of moderate/heavy water seepage, generally throughout all 3no jack arches, mainly at connection with main girders, and down inner face of both abutments. Photo 18

Photo 18 typical water seepage at jack arches 11/02/2014

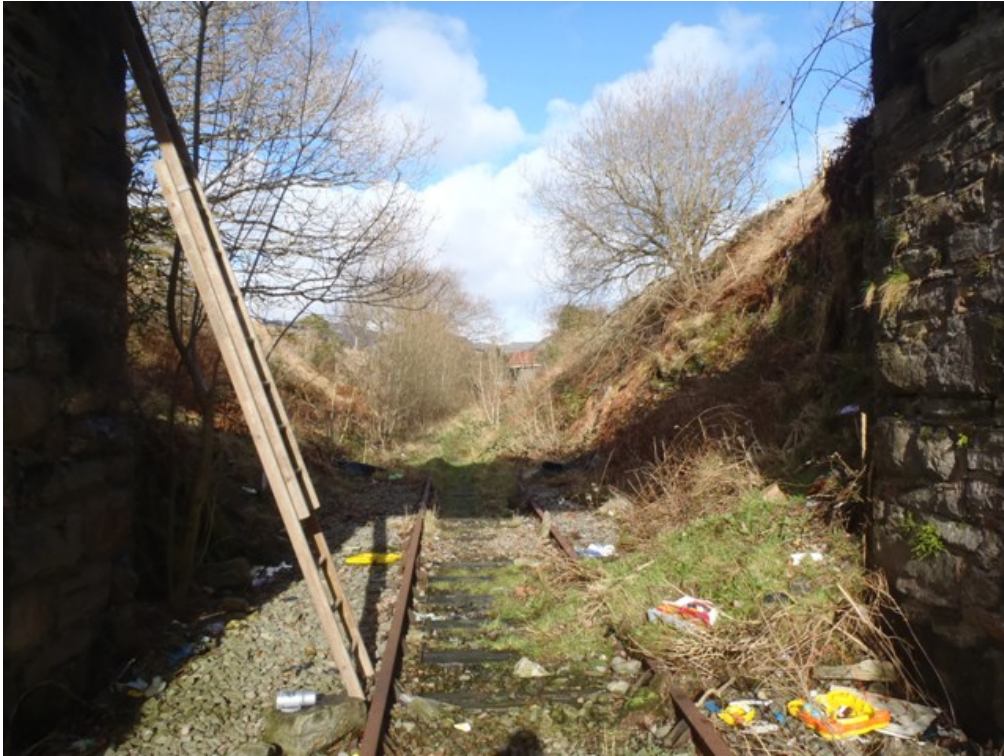
Concrete surfaced road over, leading to open fields on upside, appears little used except as a footpath. Note- this (freight only) line has not carried rail traffic for approximately 20 years, with the line in the vicinity of this structure now heavily overgrown with brambles, saplings etc. Photos 19,20

Photo 19 track view looking towards Blaenau 11/02/2014

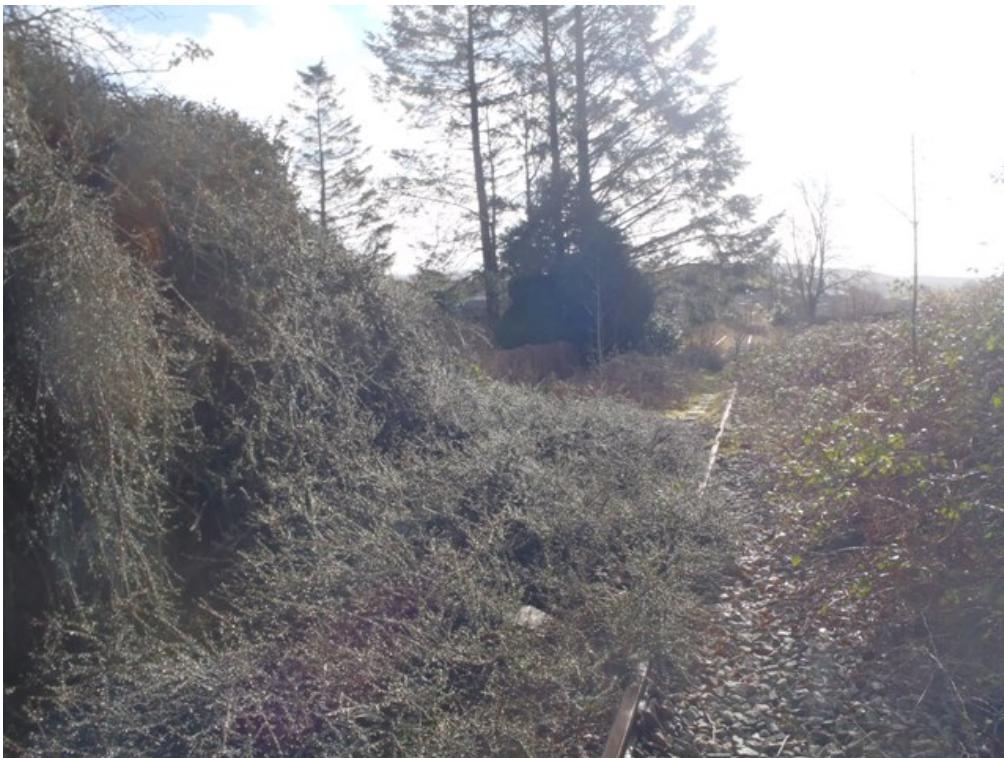
Photo 20 track view looking towards Trawsfynydd 11/02/2014

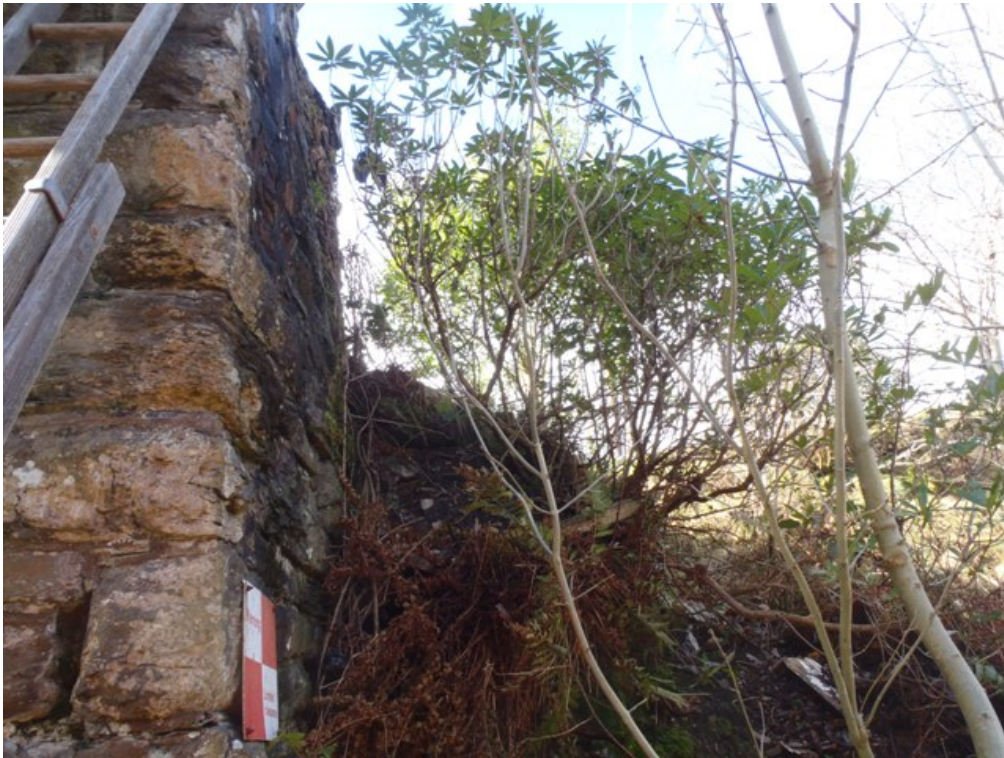
Bushes/saplings growing within 2m of all 4no outer quoins of wing walls. Photo 21

Photo 21 typical bush/sapling at wingwall quoins 11/02/2014

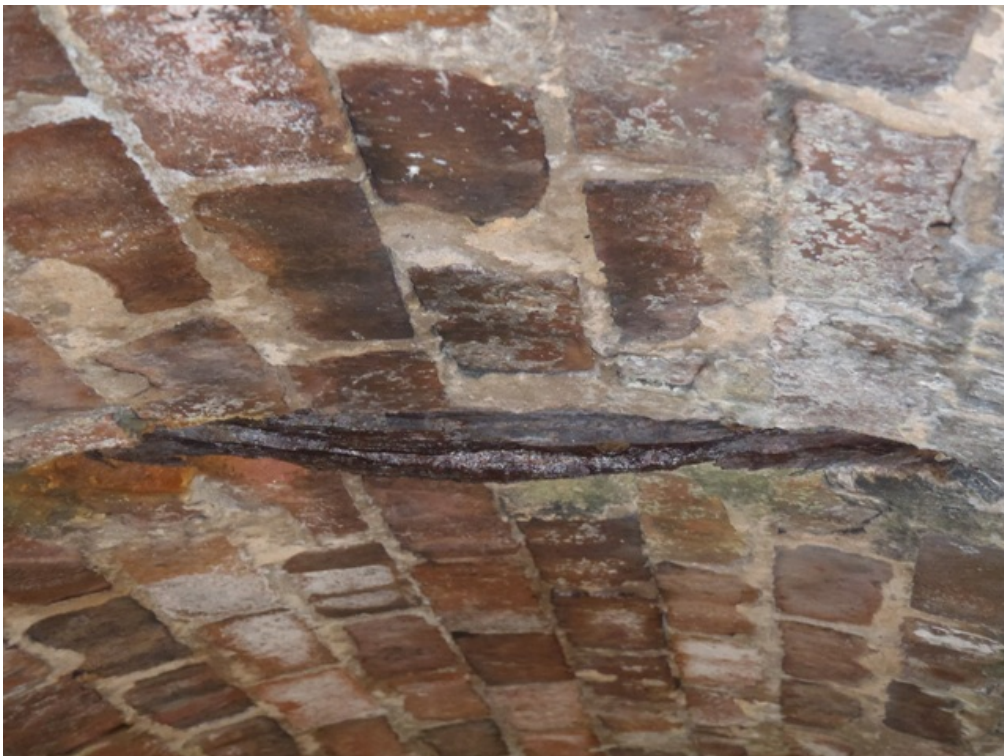
All 3no. tie bars severely corroded at connection with jack arches, wasted to 10mm out of original 35mm. Photo 22

Photo 22 typical corroded tie bar 11/02/2014

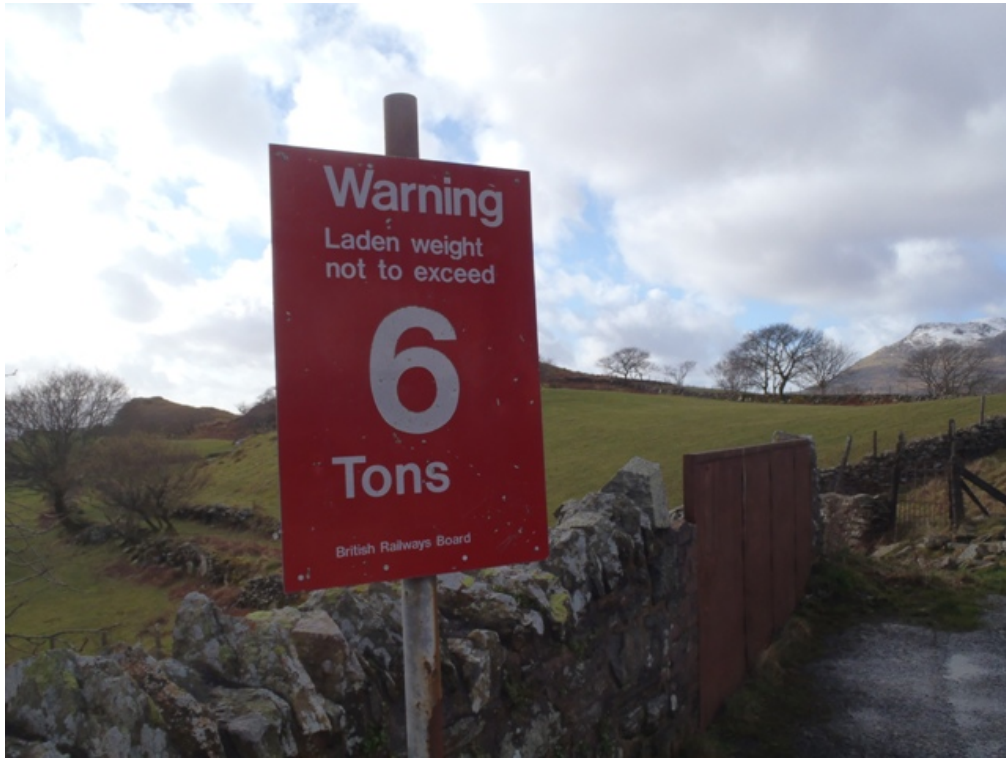
6 Ton weight restriction plates on both approaches to span – clear and visible with no evidence of non-compliance. Photo 23

Photo 23 weight restriction plate 11/02/2014
