**Bridge Detailed Examination Report**

| <b>ELR:</b> LJT2 | <b>Contract Mileage:</b> 024 m 0649 yds 29.50 chs | | | <b>Struc. Ref</b> 113 | |
| <b>Structure Name:</b> | BR113 | <b>Type:</b> | BO | <b>Exam ID</b> | 5026679 |
| <b>Route:</b> | Blaneau Ffestiniog Branch | | | <b>Complete Examination:</b> | No |

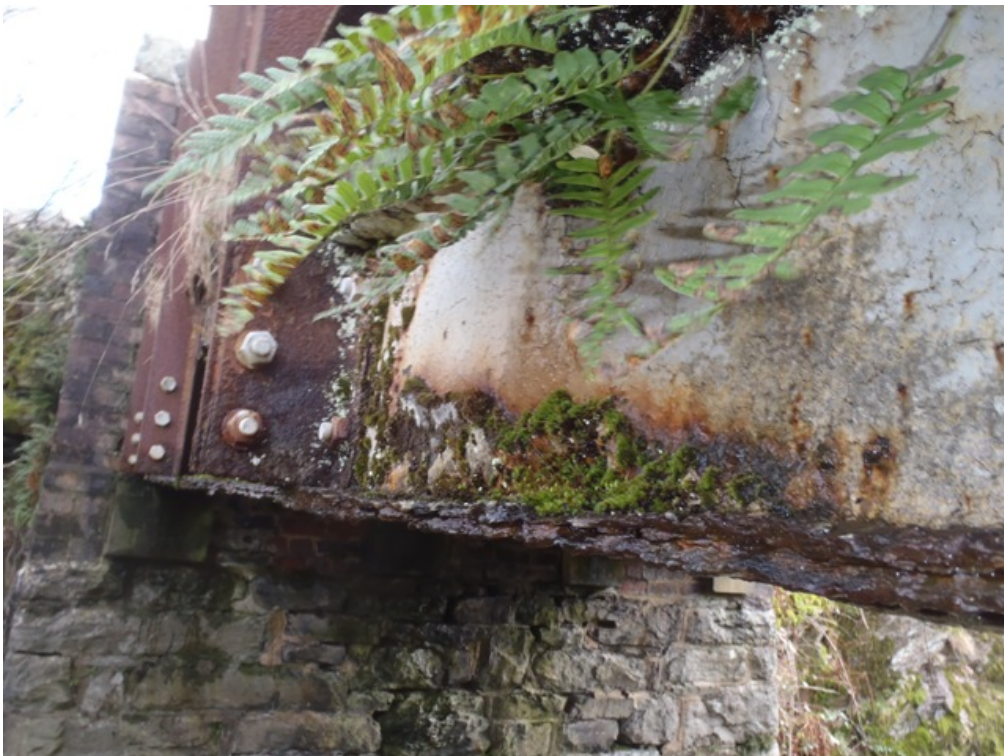
Both outer main girders – severe corrosion with knife edging throughout outer edge of top flange Photo 6,

Photo 6 typical corrosion to outer main girders 13/02/2014

| HIDDEN PARTS NOT EXAMINED<br>(EXCLUDING FOUNDATIONS) | | Part | Reason | | | | | | |
|--|--|---|---|---|---|---|---|---|---|
| 3 | Carry out site investigation to determine remaining thickness to bottom flange of main girders with an ultrasonic meter and update level 0 assessment to determine current capacity. | Main girders | 2000.00 | 1yr | 1 unit | 4 | 2 | E8 | Other |
| 4 | Remove defective paintwork throughout structure, clean exposed steel to sound surface, repair as necessary and apply an approved coating system. | Main girders and tie bars. | 10000.00 | 1yr | 1 unit | 2 | 3 | E6 | Painting |

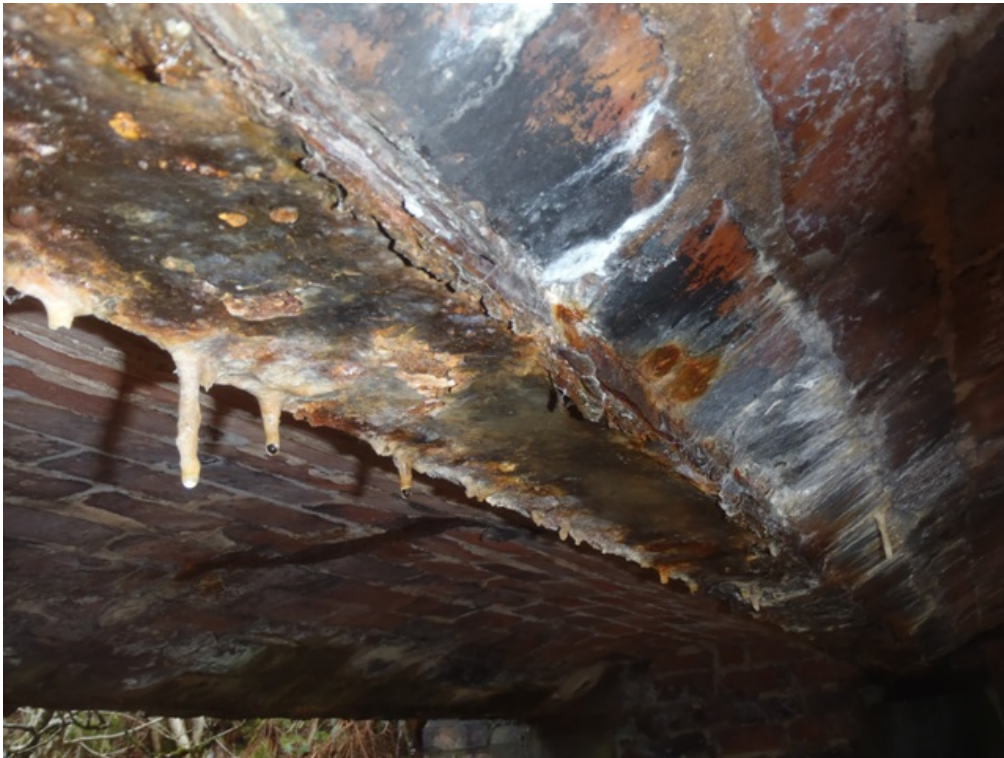
Both outer and both inner main girders – extensive moderate/severe corrosion sores throughout bottom face of bottom flange. Photo 7,

Photo 7 typical corrosion to inner main girders 13/02/2014

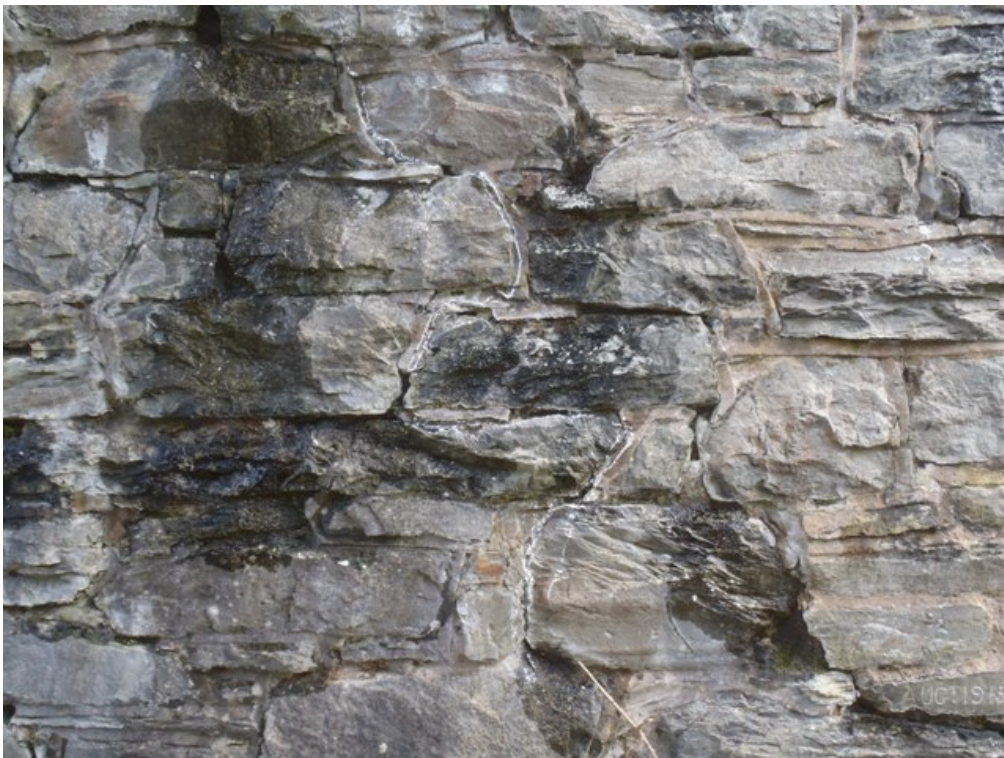
Both abutments – similar, 1mm wide vertical, stepped bed joint fractures, from ground level to top, at centre of abutments – as last detailed examination. Photos 8,9

Photo 8 fracture at downside abutment 13/02/2014

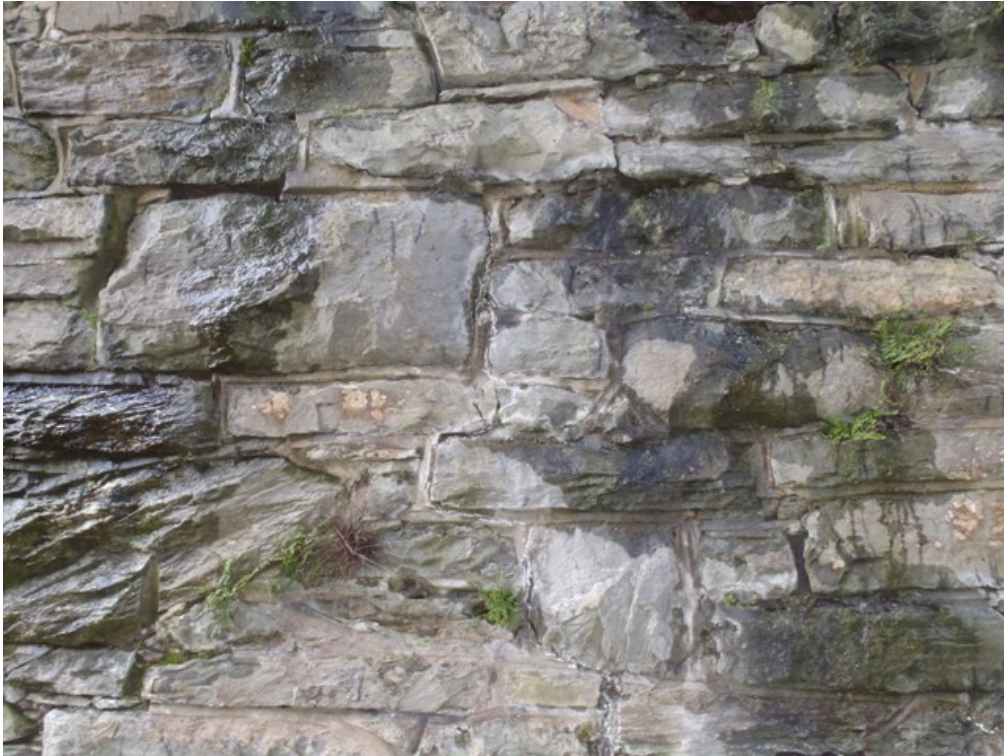
Photo 9 fracture at upside abutment 13/02/2014

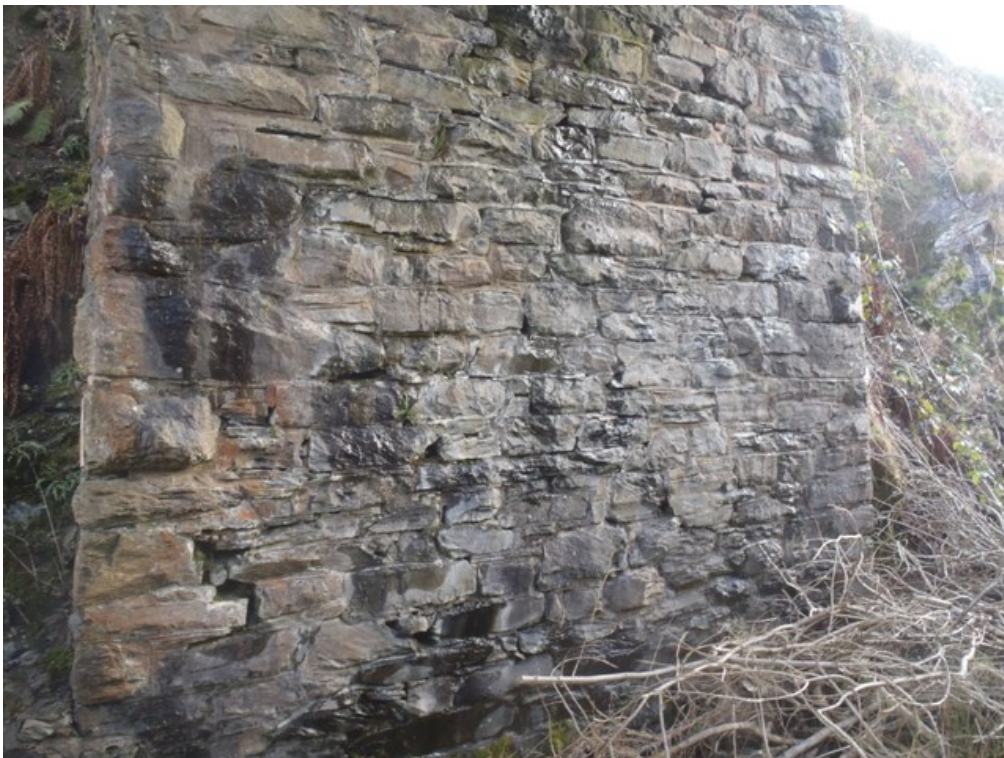
Open joints/missing stones to 150mm deep, generally throughout both abutments – 20m.sq total. Photos 10,11

Photo 10 open joints at downside abutment 13/02/2014

| HIDDEN PARTS NOT EXAMINED<br>(EXCLUDING FOUNDATIONS) | | Part | Reason | | | | | | |
|--|--|---|---|---|---|---|---|---|---|
| 5 | Rake out to sound material and re-point isolated areas of deep open joints. Replace isolates missing stones to abutment. | Abutments, wingwalls and parapets | 6000.00 | 4yrs | 40 m2 | 2 | 3 | M6 | Hand Pointing |

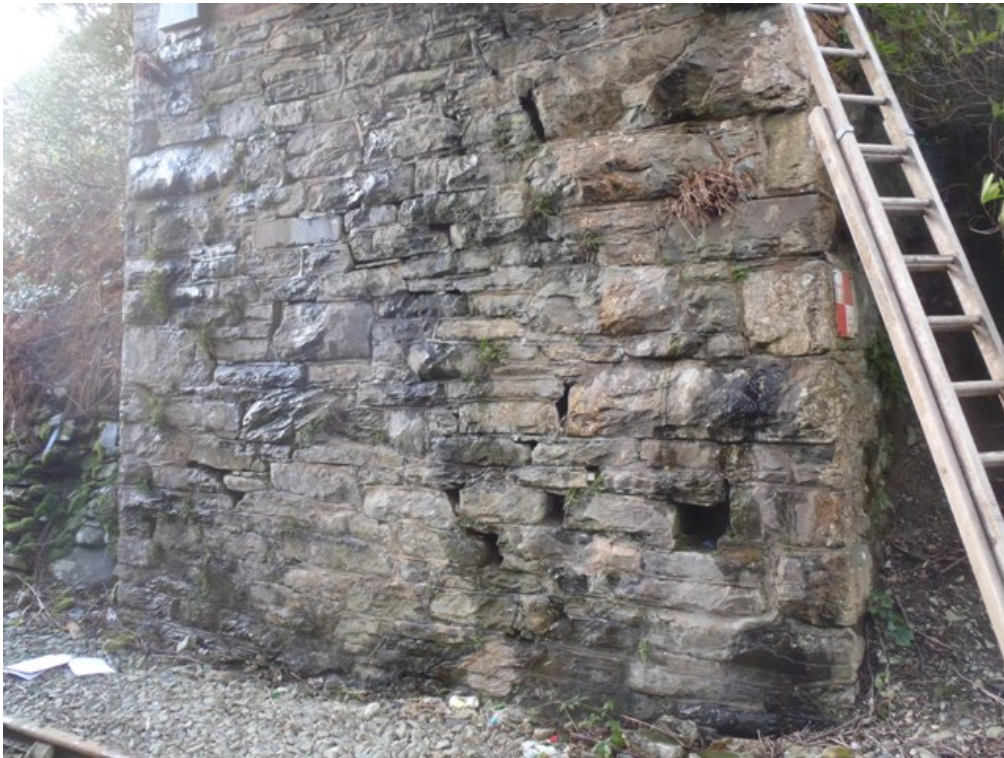
Occasional, isolated missing stones, to 150mm sq., generally throughout upside abutment. Photo 11

Photo 11 open joints at upside abutment 13/02/2014

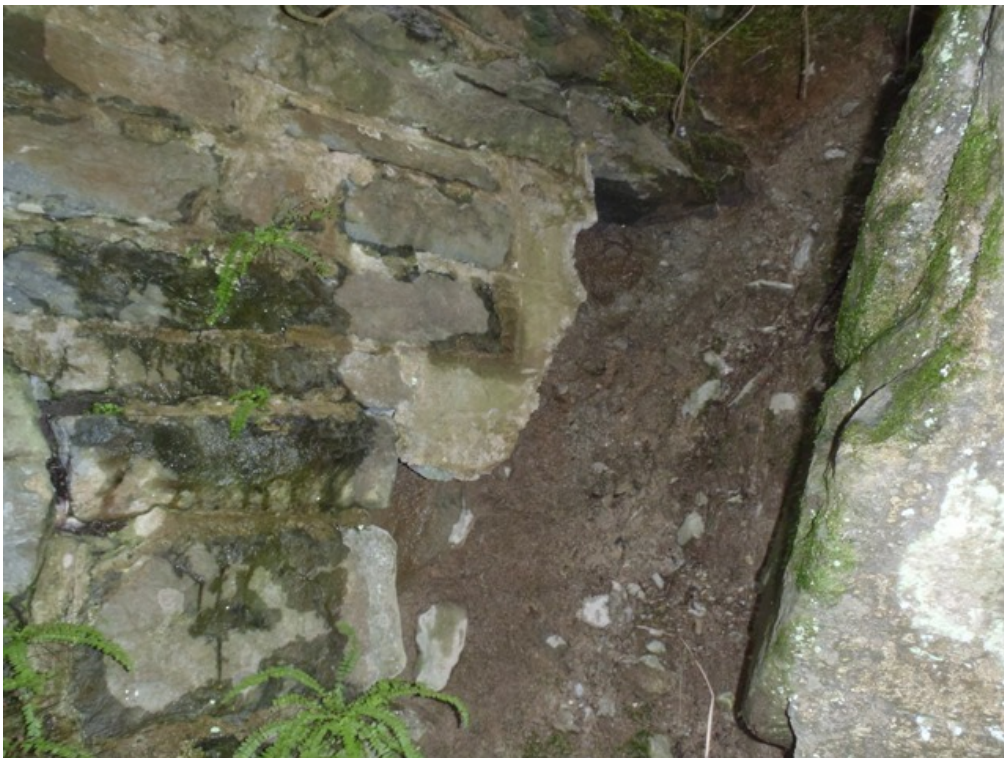
| No | Description | Location | Exam Date | Access Gained | Exam Type | Rec Raised | Risk Score | Access Req'd | Deter - ioration | Repaired | Flagged for Closure | Engineer Comments |
|---|---|---|---|---|---|---|---|---|---|---|---|---|
| 4 | Void in stonework | Upside high mileage wingwall | 13/02/14 | Y | D | Y | 6 | N | Baseline | N/A | N | 1.2m long x 0.4m wide x 0.3m deep at base of wall adjacent to embankment. |

Upside, Blaenau end wing wall – area of void, 1.2m. long x 400mm wide x 300mm deep, at connection between base of wall and embankment – suspect washout to embankment, beneath the base of the wall, of longstanding. Photo 12

Photo 12 void at upside Blaenau end wing wall 13/02/2014

| HIDDEN PARTS NOT EXAMINED<br>(EXCLUDING FOUNDATIONS) | | Part | Reason | | | | | | |
|--|--|---|---|---|---|---|---|---|---|
| 8 | Replace and make good missing stonework. | Upside high mileage wingwall/embankment | 750.00 | 3yrs | 0.15 m3 | 2 | 3 | S6 | Brickwork/Stone Repairs |

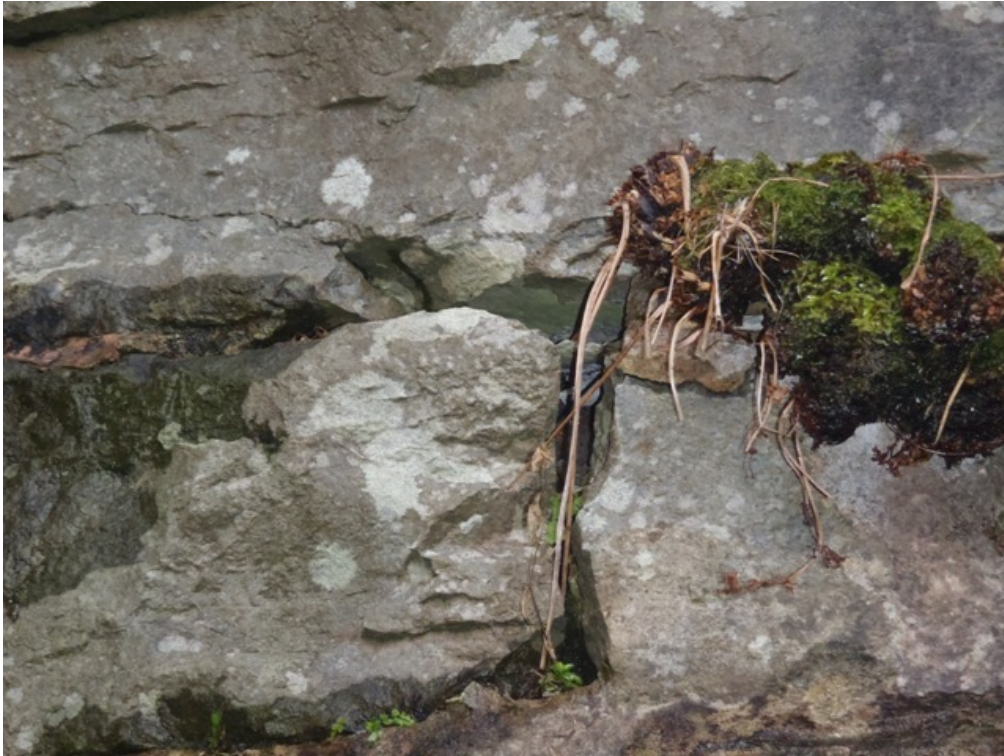
Occasional, isolated open joints, to 100mm deep, generally throughout all 4no wing walls – 8m.sq total. Photo 13

Photo 13 typical open joint at wing walls 13/02/2014

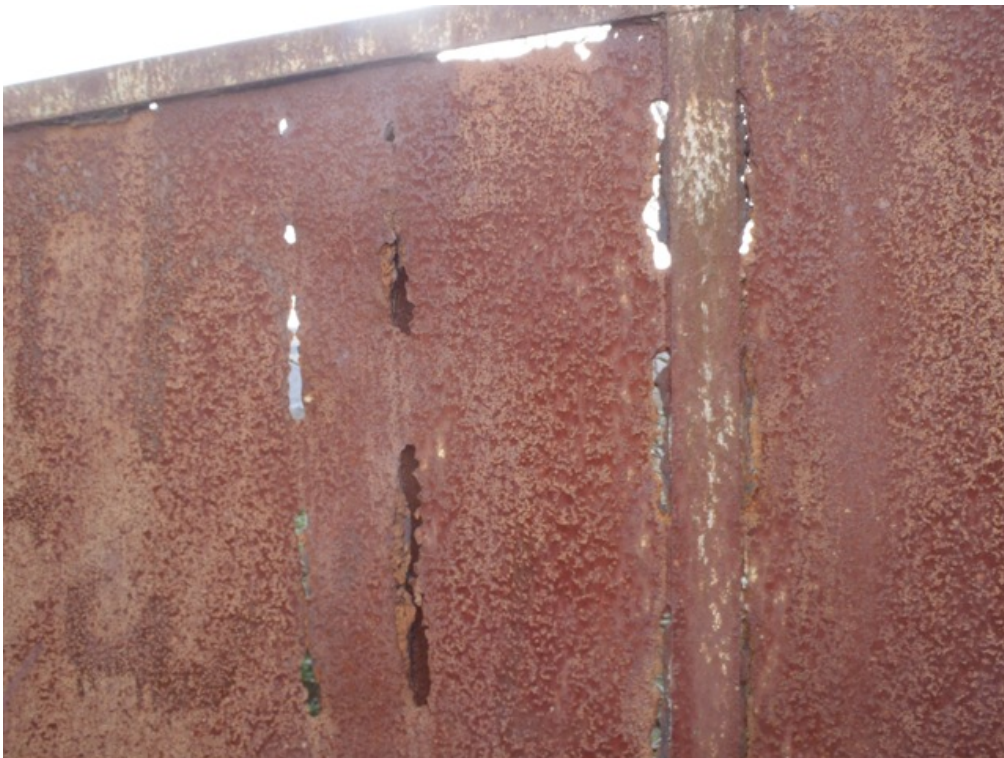
| No | Description | Location | Exam Date | Access Gained | Exam Type | Rec Raised | Risk Score | Access Req'd | Deter - ioration | Repaired | Flagged for Closure | Engineer Comments |
|---|---|---|---|---|---|---|---|---|---|---|---|---|
| 2 | Severely corroded and holed parapet screens | Parapets | 13/02/14 | Y | D | Y | 10 | N | N | N | N | The corroded parapet panels could easily be damaged by farm vehicles and offer very little protection in thier current condition. |

All 3no plate panels on each parapet severely corroded, with numerous holes, to 50mm diameter, and knife edging around, mainly at connection with angle stiffeners. Photos 14,15

Photo 14 corrosion to Blaenau end parapet 13/02/2014

| HIDDEN PARTS NOT EXAMINED<br>(EXCLUDING FOUNDATIONS) | | Part | Reason | | | | | | |
|--|--|---|---|---|---|---|---|---|---|
| 6 | Replace parapet plates | Both elevations | 5000.00 | 6mths | 1 unit | 5 | 2 | M10 | Steelwork Repairs |

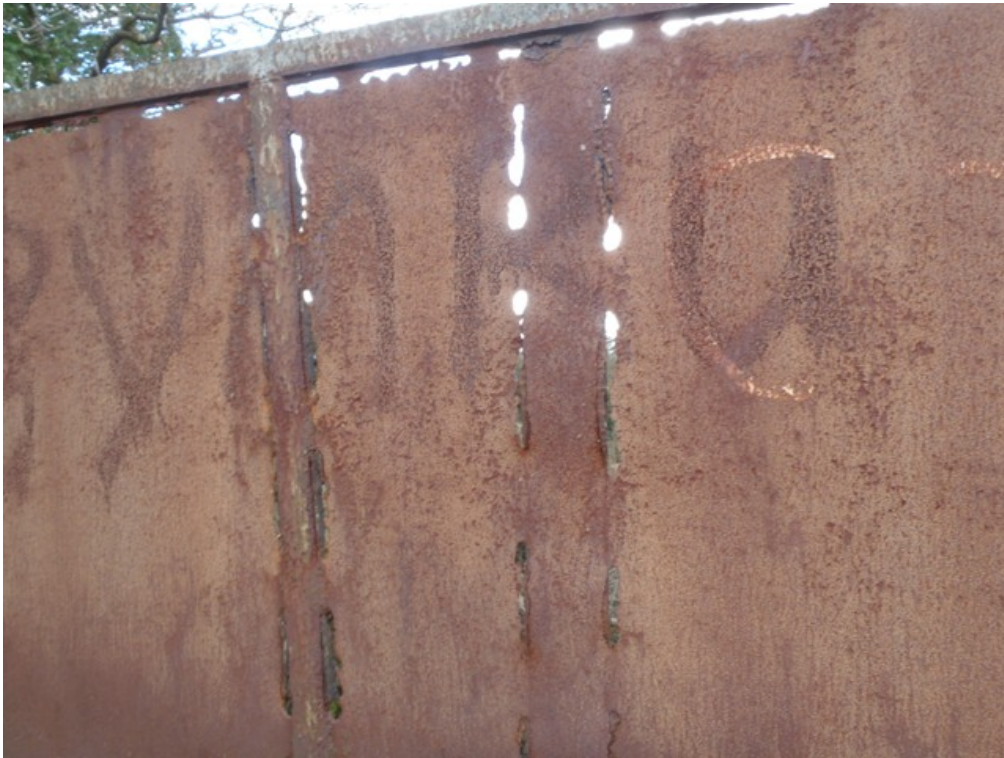
Photo 15 corrosion to Trawsfynydd end parapet 13/02/2014

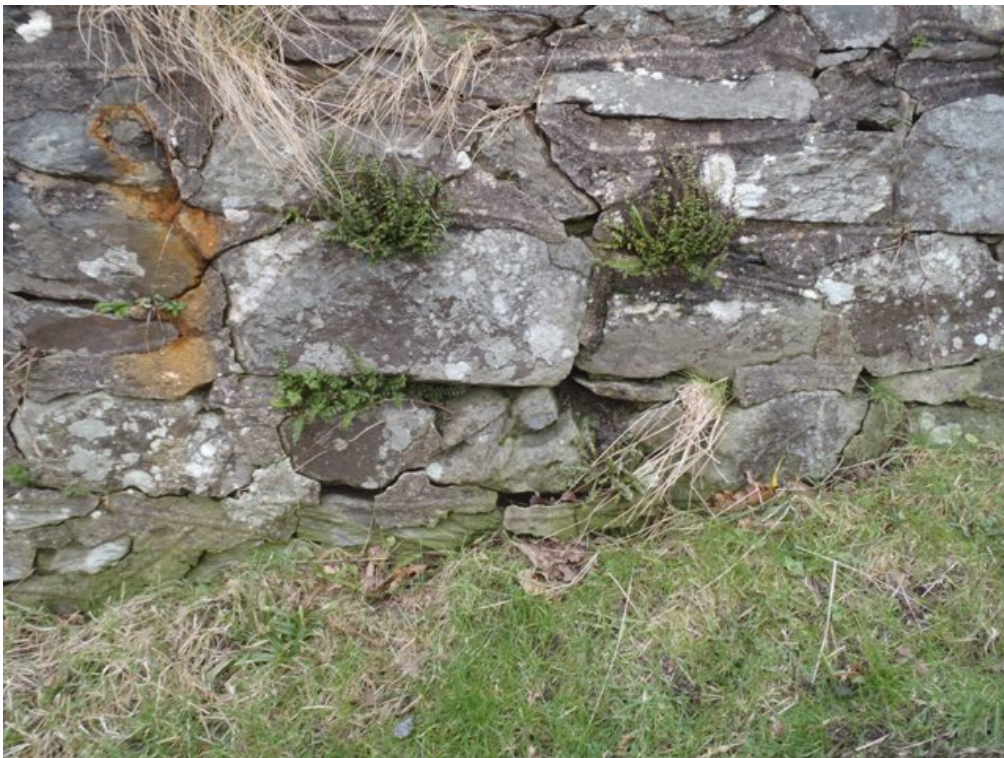
Occasional, isolated open joints, to 100mm deep, generally throughout all 4no parapet approach walls – 8.sq total. Photo 16

Photo 16 typical open joints at parapets 13/02/2014

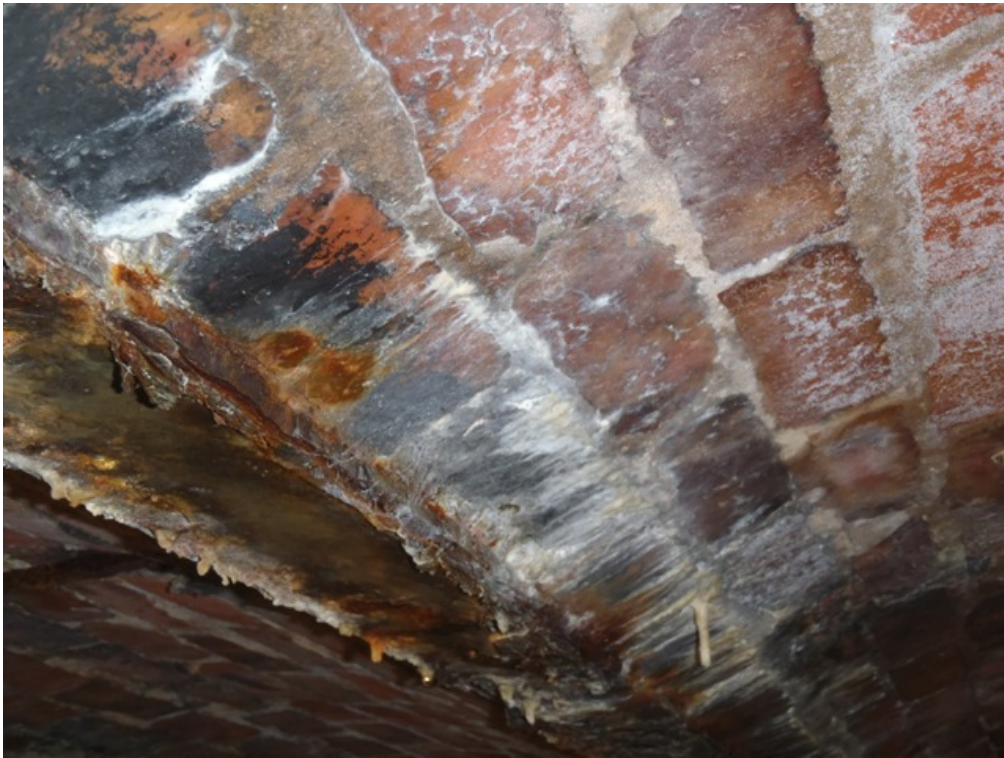
Areas of moderate/heavy water seepage, generally throughout all 3no jack arches, mainly at connection with main girders, and down inner face of both abutments and all 8no pad stones Photos 17, 18, 19

Photo 17 typical water staining at jack arches 13/02/2014

| HIDDEN PARTS NOT EXAMINED<br>(EXCLUDING FOUNDATIONS) | | Part | Reason | | | | | | |
|--|--|---|---|---|---|---|---|---|---|
| 9 | Consider rewaterproofing the structure as part of programmed maintenance work. | Deck | 10000.00 | 4yrs | 1 unit | 2 | 3 | E6 | Other |

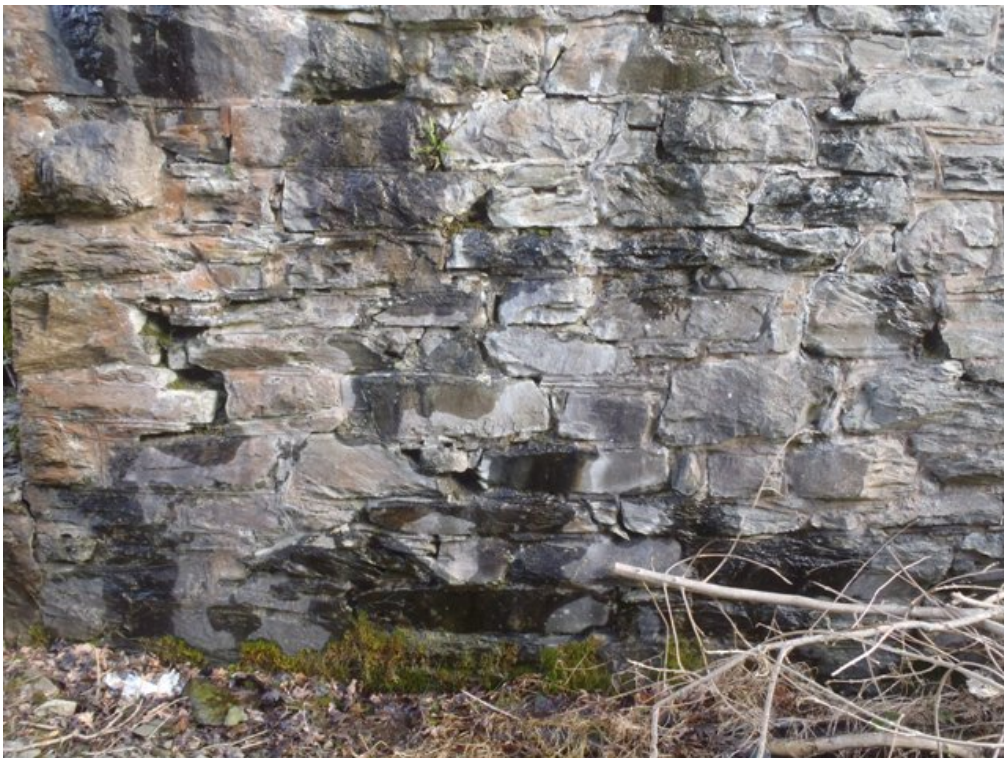
Photo 18 typical water staining at abutments 13/02/2014

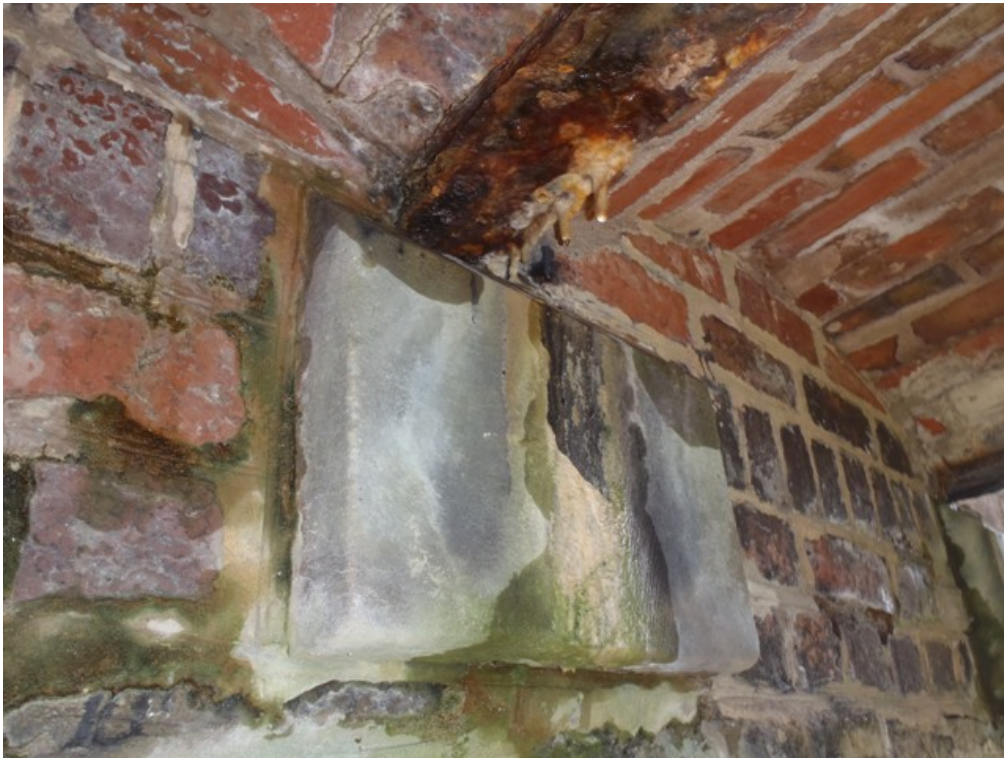
Photo 19 typical water staining at pad stones 13/02/2014

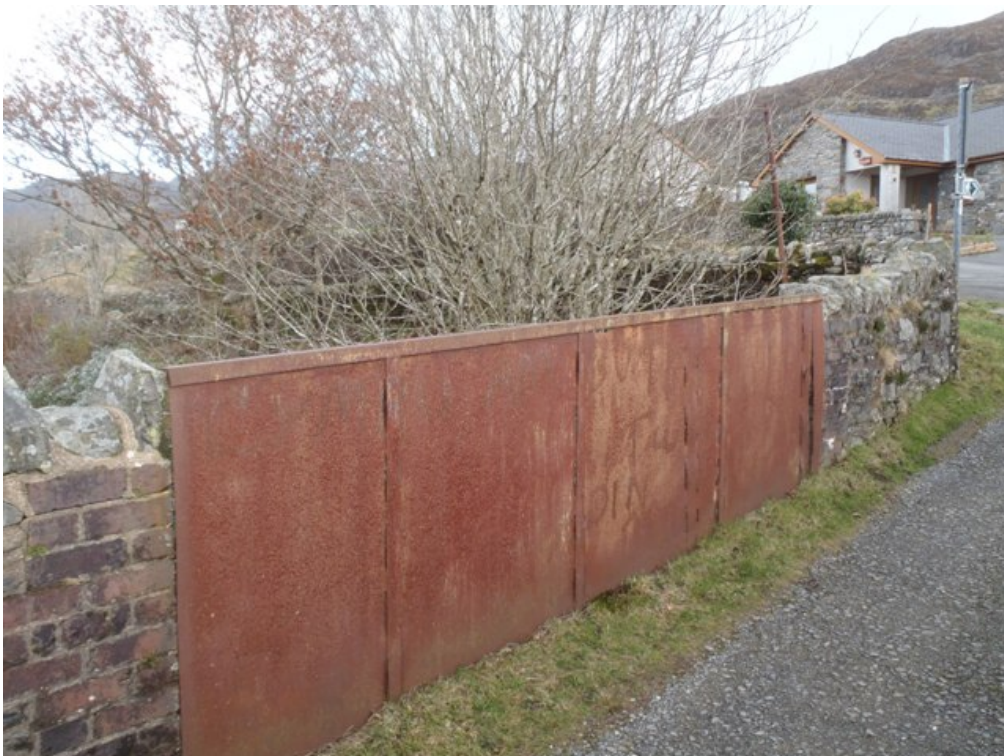
Paint cover generally broken down, and now largely non-existent - allowing extensive corrosion throughout superstructure. Photo 20.

Photo 20 typical paint break down at parapets 13/02/2014

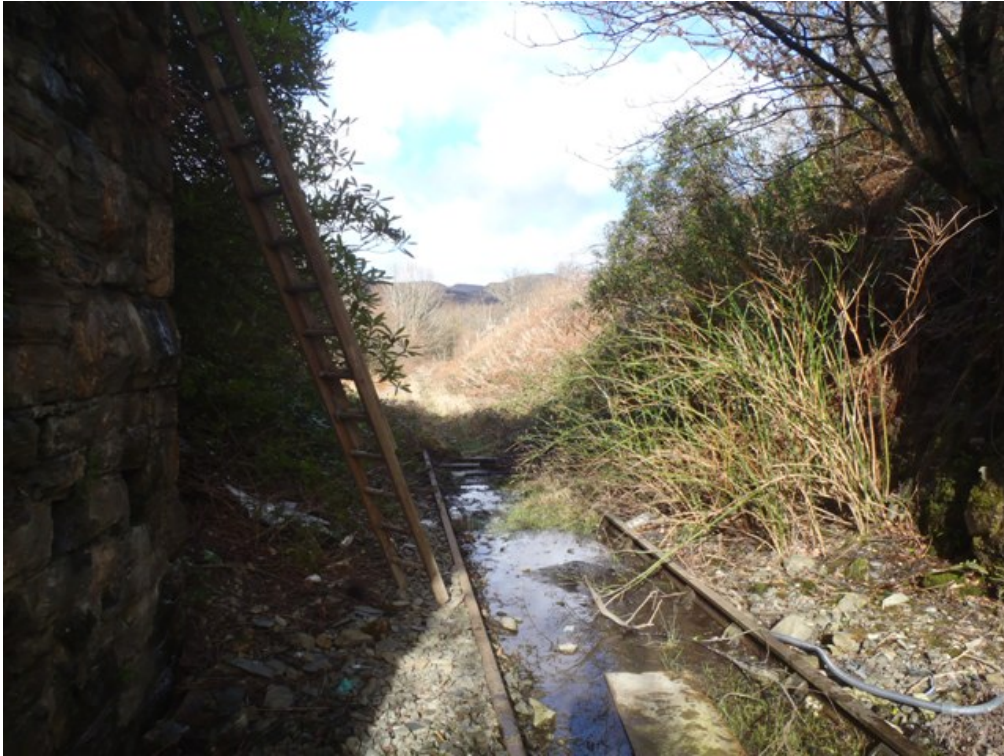
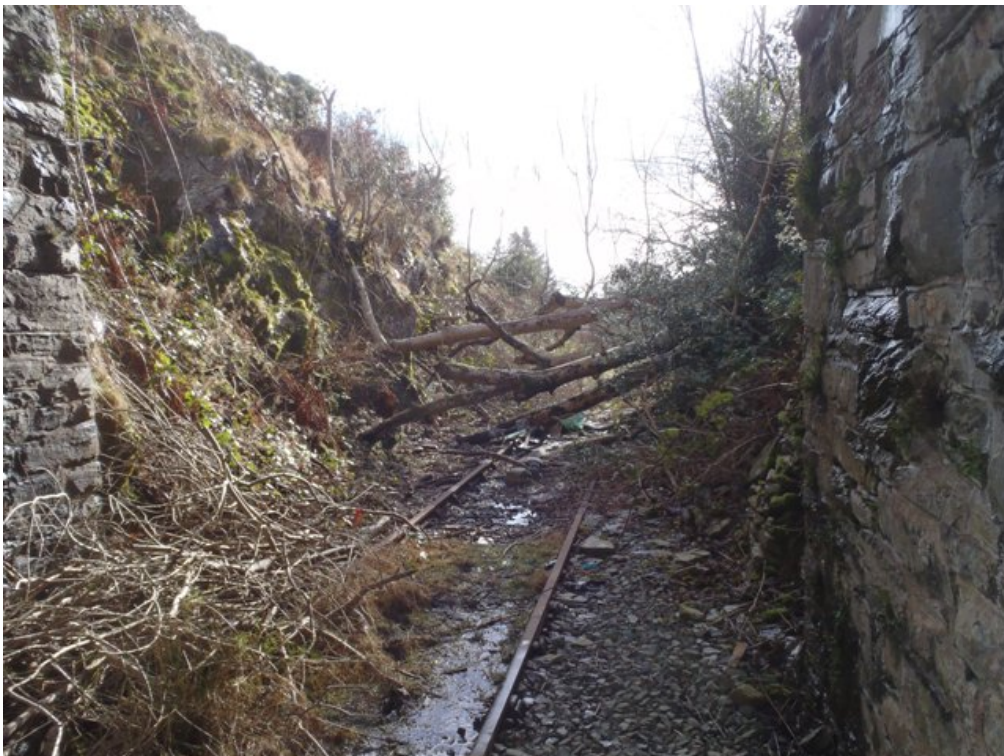
Note- this (freight only) line has not carried rail traffic for approximately 20 years, with the line in the vicinity of this structure now heavily overgrown with brambles, saplings etc., with a fallen tree partially blocking the branch line, 10m towards the Trawsfynydd end Photos 21, 22

Photo 21 track view looking towards Blaenau 13/02/2014

Photo 22 track view looking towards Trawsfynydd 13/02/2014

| HIDDEN PARTS NOT EXAMINED<br>(EXCLUDING FOUNDATIONS) | | Part | Reason | | | | | | |
|--|--|---|---|---|---|---|---|---|---|
| 7 | Remove fallen tree | Trawsfynydd end of bridge | 750.00 | 1yr | 1 unit | 5 | 2 | M10 | Vegetation |

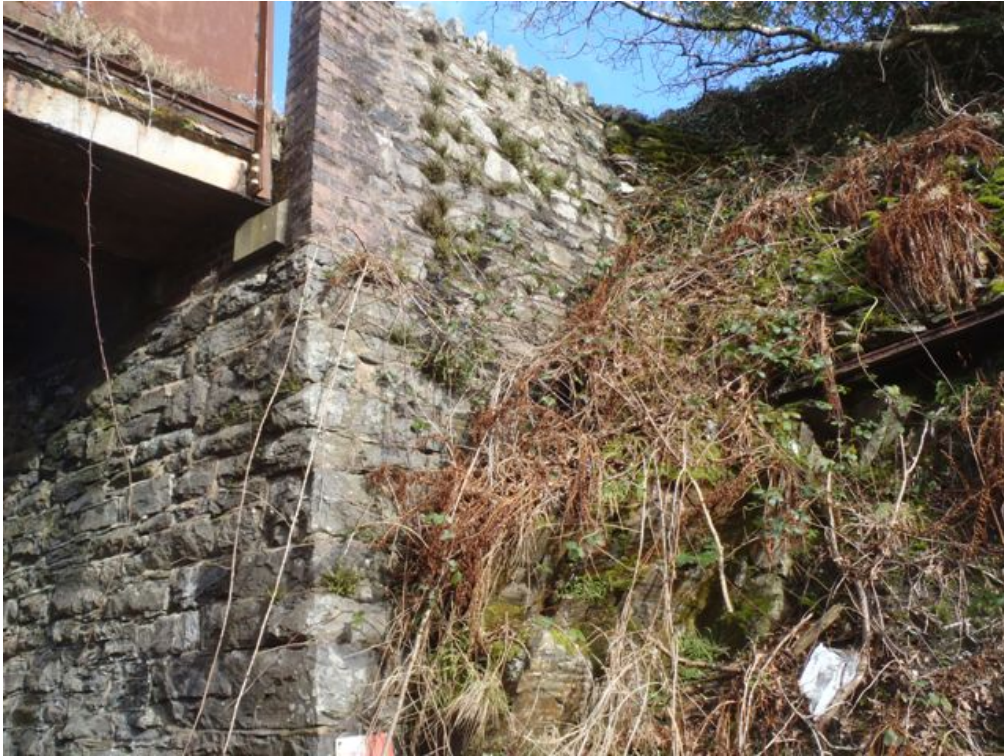
Bushes/saplings growing in embankment within 2m of all 4no wing walls. Photo 23

Photo 23 vegetation at wing walls 13/02/2014

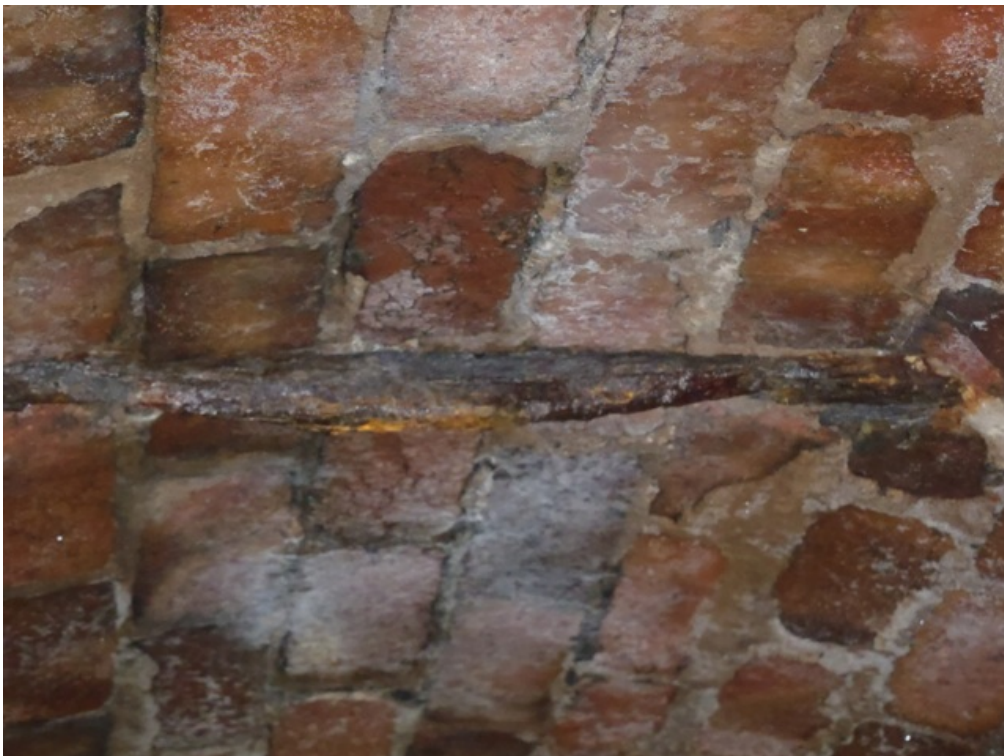
All 3no. tie bars severely corroded at connection with jack arches, wasted to 10mm out of original 35mm. Photo 24

Photo 24 corroded tie bar 13/02/2014

| HIDDEN PARTS NOT EXAMINED<br>(EXCLUDING FOUNDATIONS) | | Part | Reason | | | | | | |
|--|--|---|---|---|---|---|---|---|---|
| 2 | Carry out HCE examination to confirm condition of main girders hidden by jack arches and tie bar ends (JAS, BZ and CUFPO). | Main girders and tie bars | 2000.00 | 1yr | 1 unit | 4 | 2 | E8 | Other |

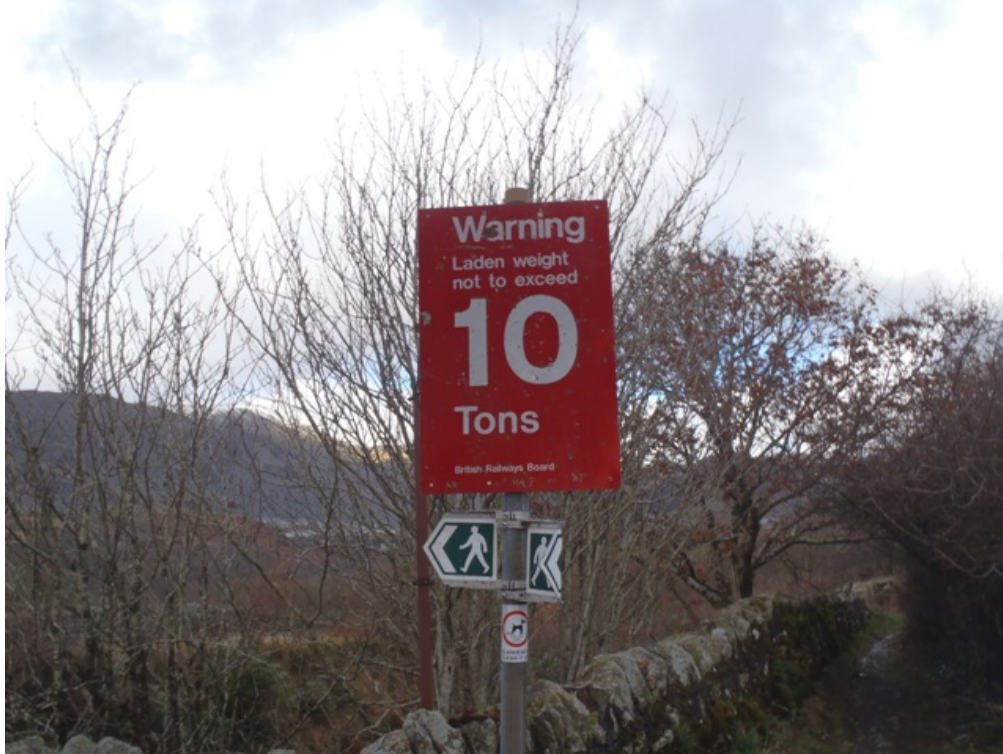
10 Ton weight restriction plates on both approaches to span – clear and visible with no evidence of non-compliance. Photo 25

Photo 25 signage 13/02/2014
